## Service Bulletin

SB # 246

### IQ5 & IQ6 - Troubleshooting door gasket

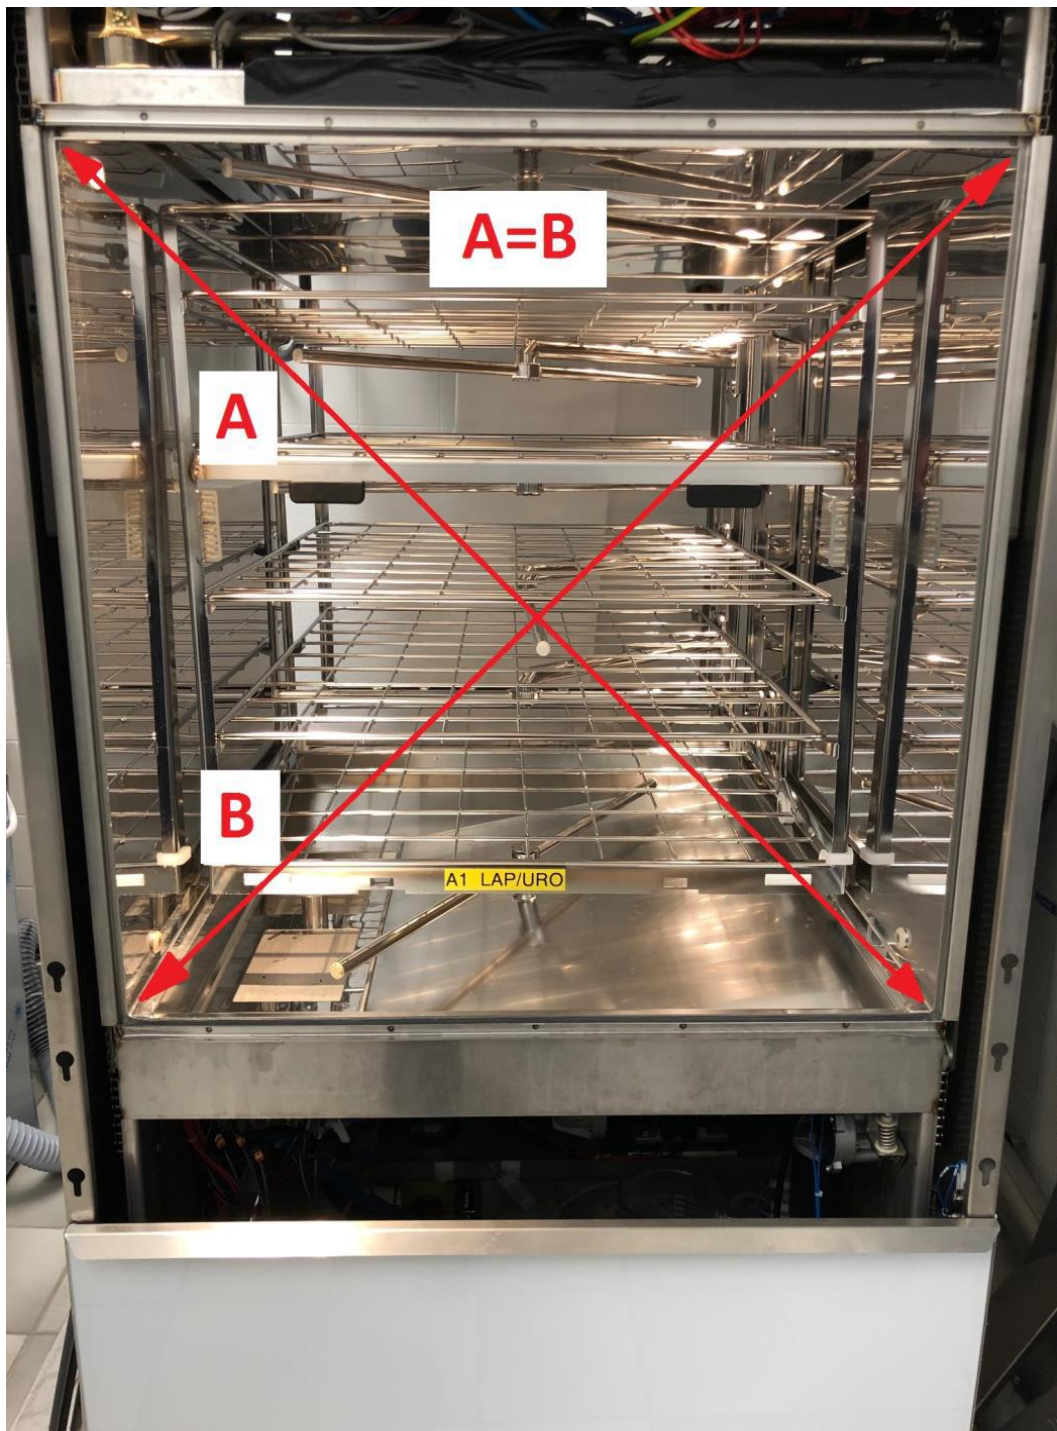
1. Make sure that the machine is leveled correct, and control the diagonal measurement.

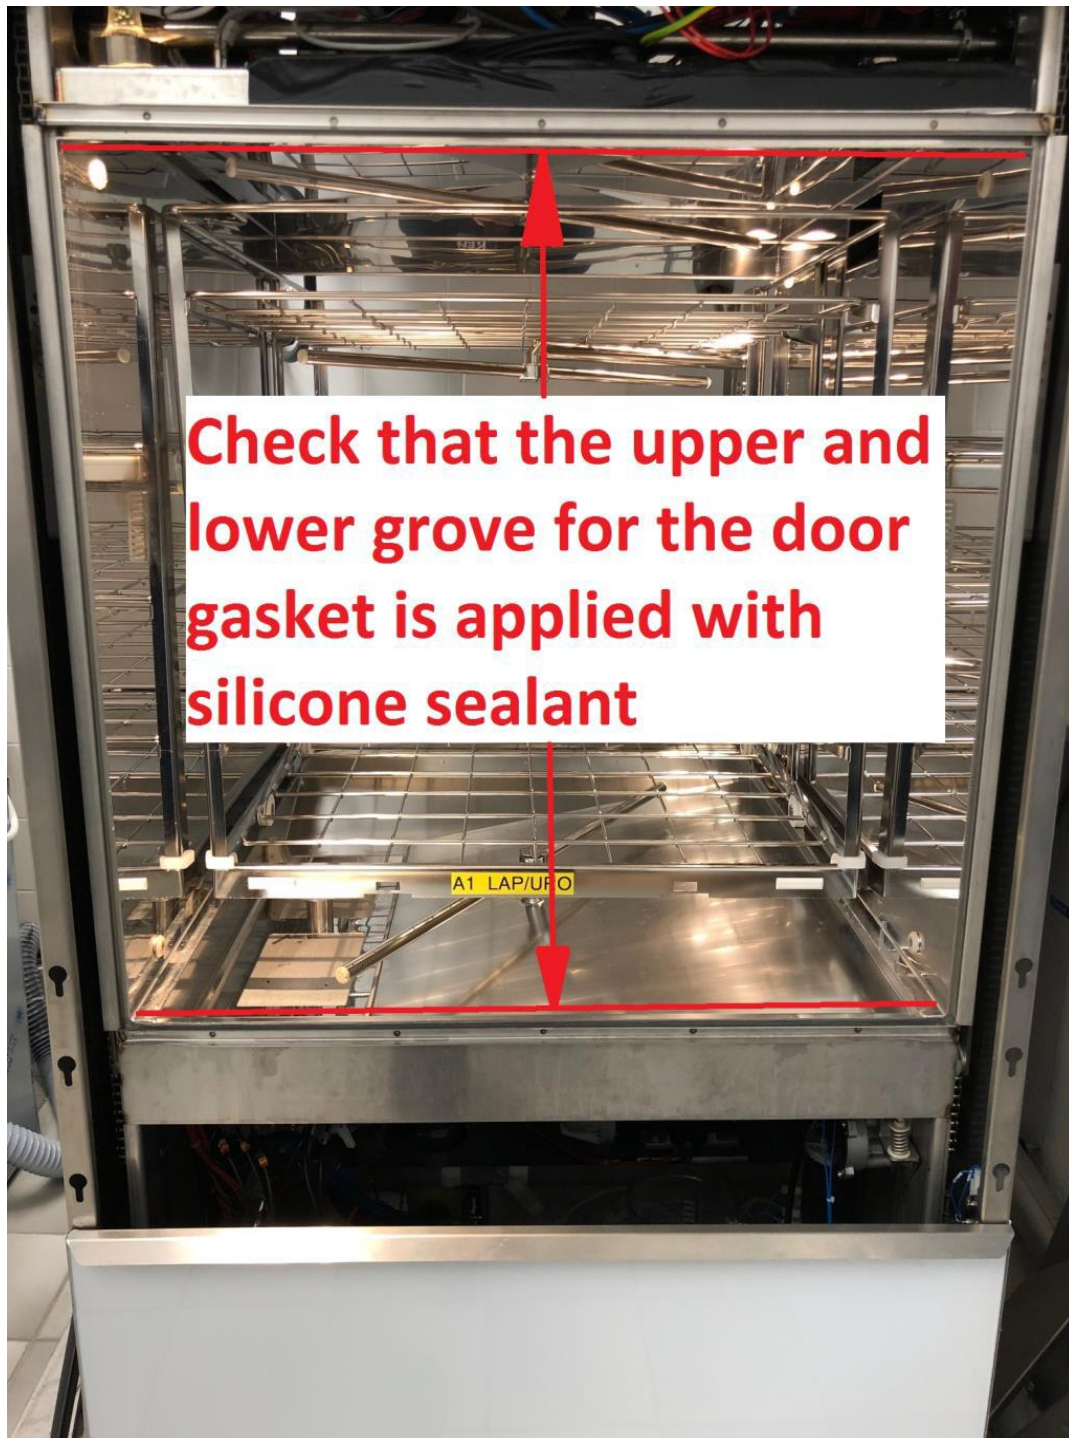
2. Check that the groves for the door gasket are clean and applied wit silicone sealant.

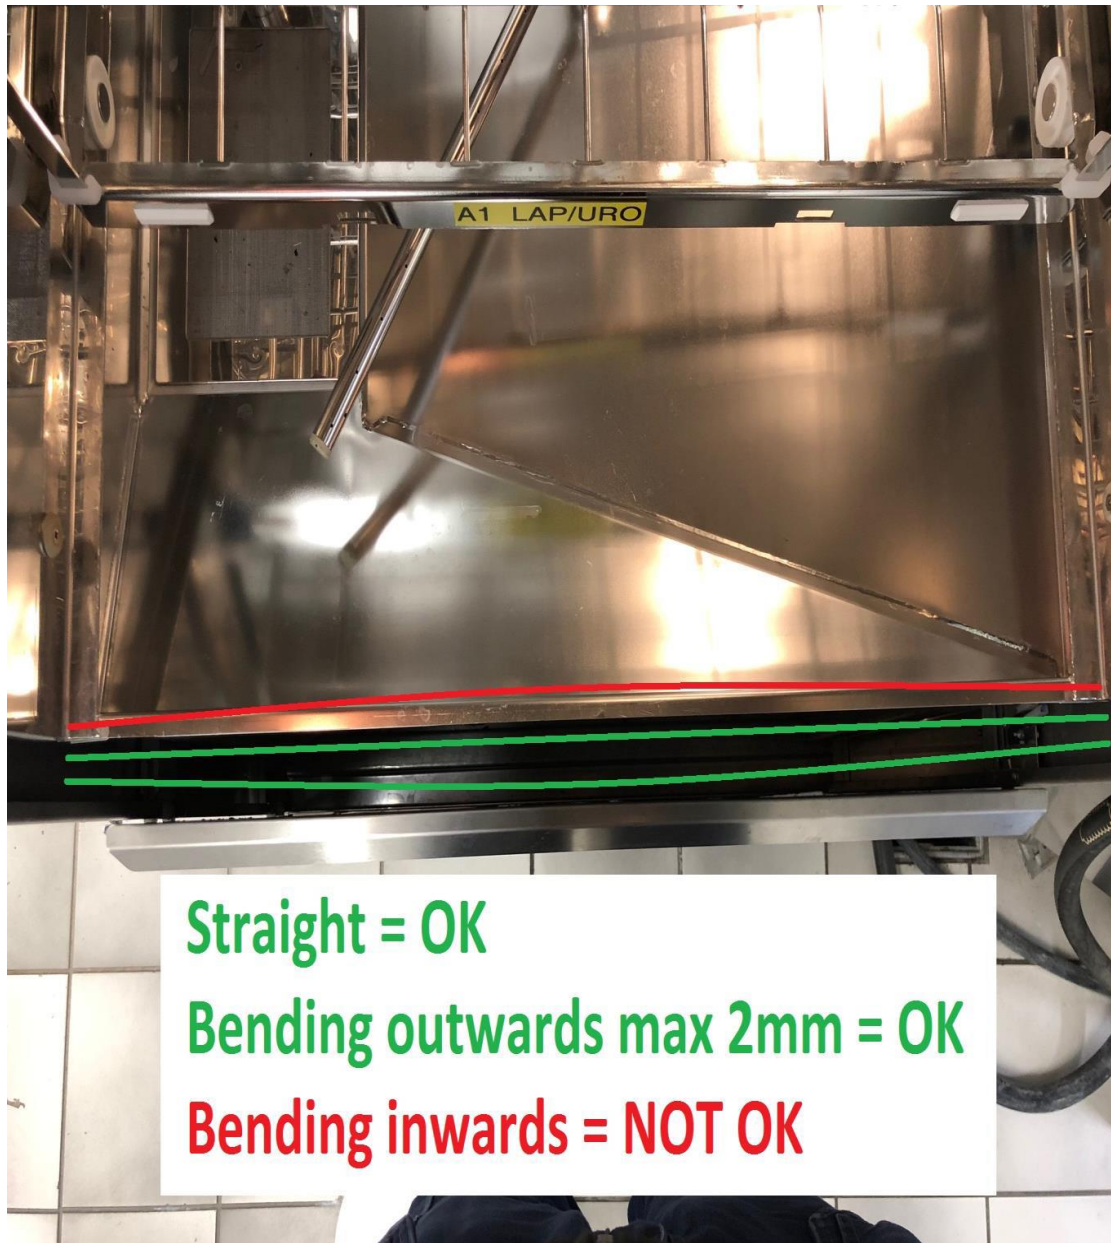
3. Check if the chamber is bending in or outwards. If it is not within the limits shown below, then it may be carefully adjusted with a nylon or rubber hammer.

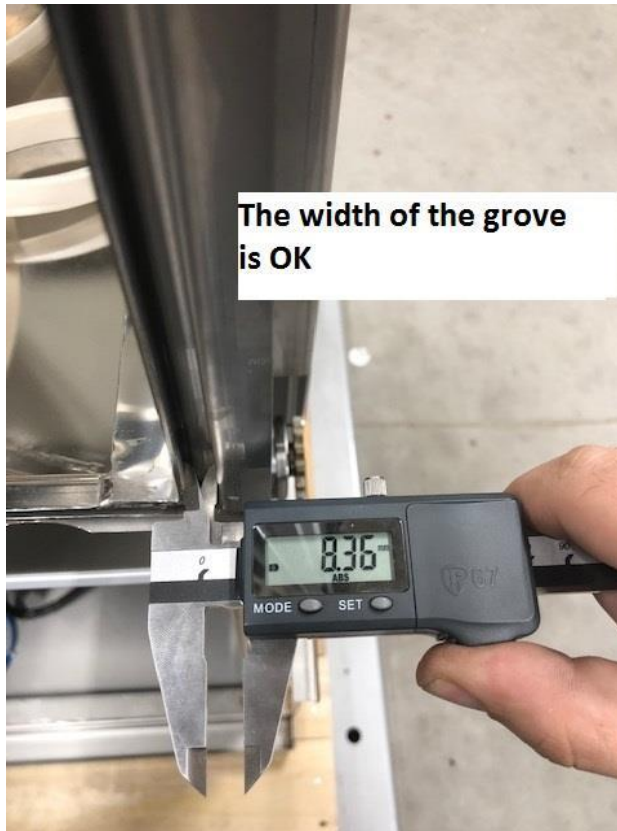
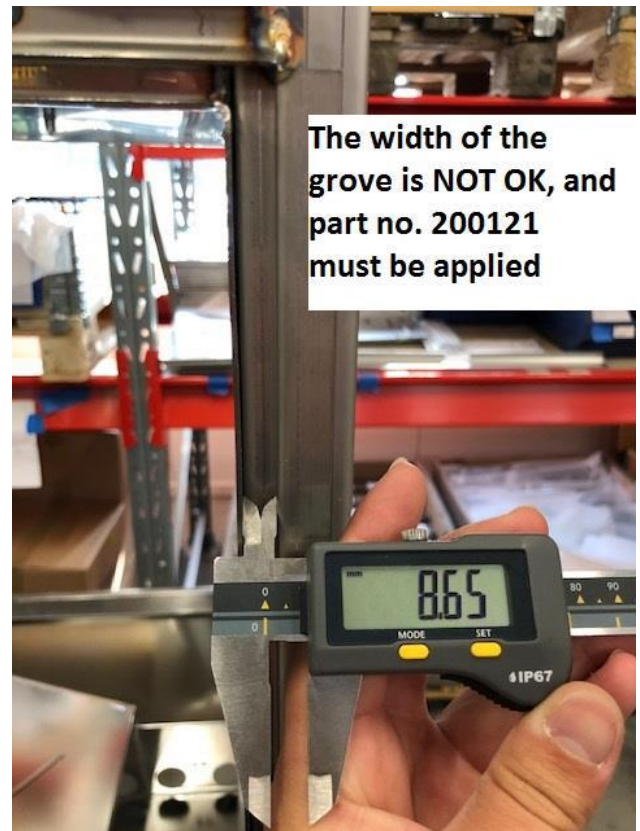
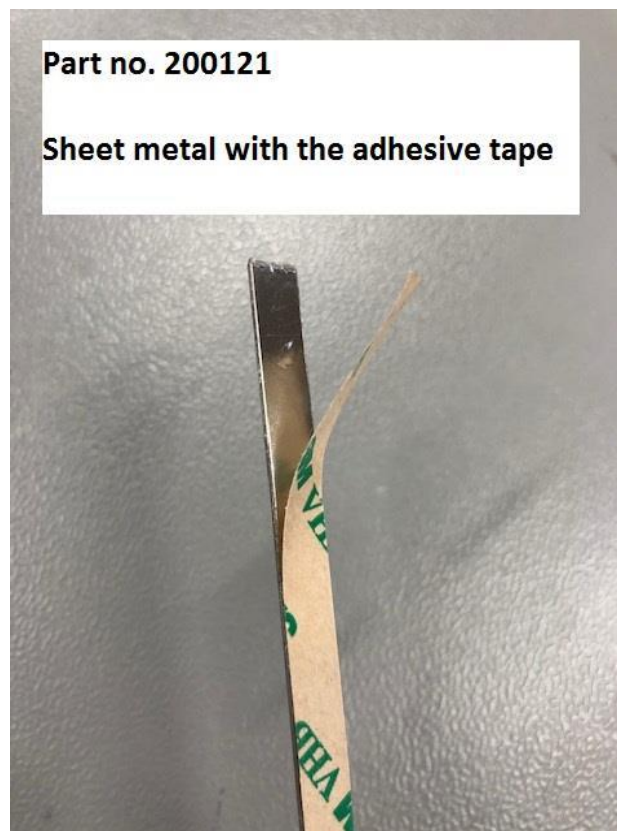
4. Check the width of the groove for the door gasket. The groove must be between 7,5 and 8,5 mm in width. If the groove is larger than 8,5 mm in width, there must be applied part # 200121, which is a piece of sheet metal with adhesive tape.
